Confidential Inspection Report

6003 Laurel Lane
Prospect, KY 40059

Report: 0000261

Date: August 5, 2009

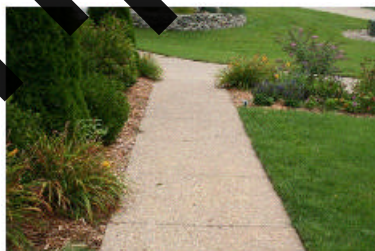
Walks:

Sidewalk type: Concrete.

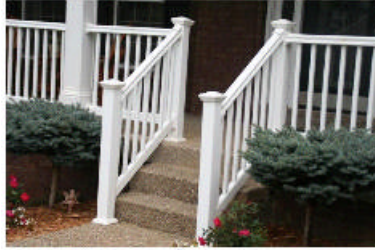
Exterior Steps / Stoops:

Handrails serviceable.

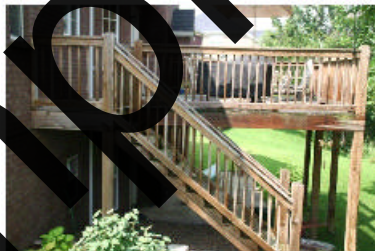
Wood, Maintain deck surface.

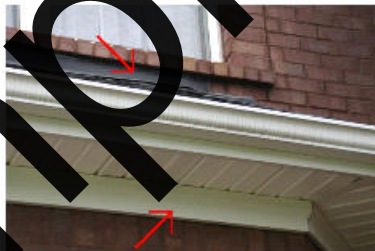
Walls are constructed with: Brick.

Metal materials. Vinyl materials.

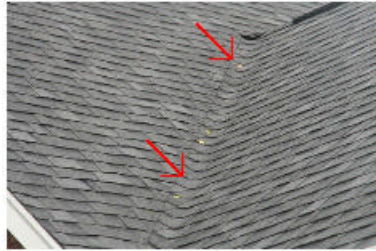
Valleys:

p " " Satisfactory - The valleys appear to be in satisfactory condition. The valleys on the roof are closed, using either overlapping or interwoven strip shingles from both intersecting roof lines.

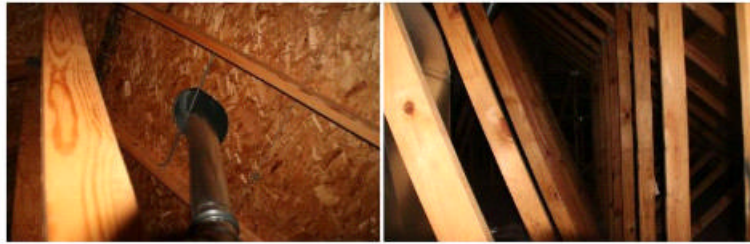
A truss system is installed in the attic cavity that is used to support the roof decking and transmit the roof load to the exterior walls. The rafters or truss system appears to be in satisfactory condition. The rafter spacing is 24 inch on center. The roof decking material is oriented strand board sheathing. The builder installed ply clips when installing the sheathing to prevent the sheathing from sagging at the joints.

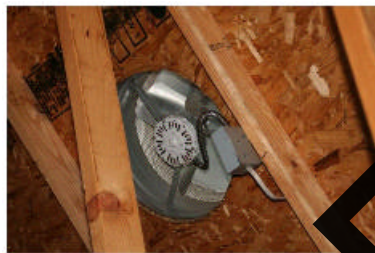
Ventilation:

␣ " " Satisfactory - There appears to be adequate ventilation installed. Vents are located both in the ridge area and low in the eaves area.

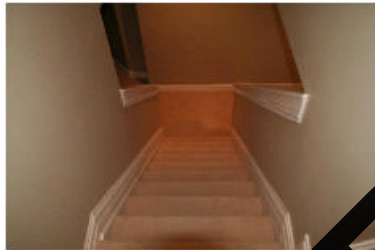
Access:

Basement is fully accessible, Basement is finished, Stairs and handrail serviceable.

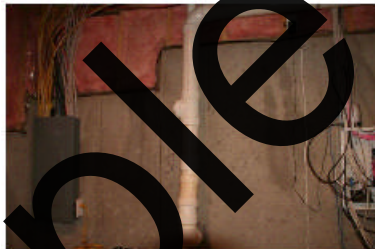
Walls:

Walls are poured concrete. Exposed portions of the interior foundation perimeter walls appear to be satisfactory.

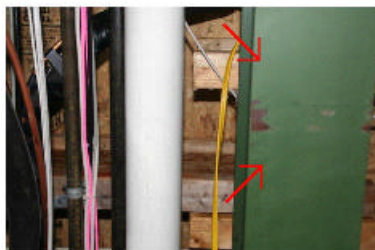
Beams Under floor:

Satisfactory - The main beam installed appears to be in satisfactory condition. The main beam is made of steel.

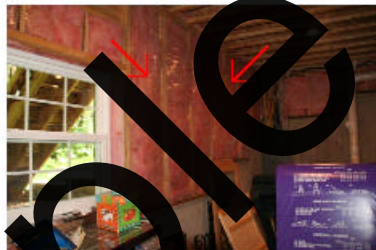
p " " There is a vapor barrier installed. The walls have a vapor barrier installed that deters moisture from entering the crawlspace through the walls.

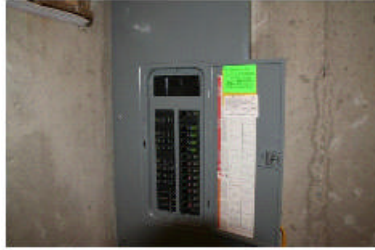
Main Panel Location:

Basement, Appears serviceable.

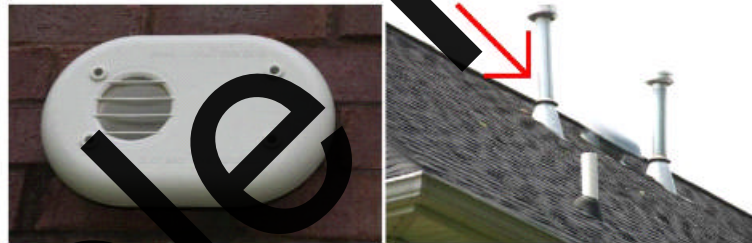
The flue pipe is plastic from the furnace to the exterior on the basement unit and The flue pipe is metal on the second floor unit. The flue appears to be lined with a metal liner.

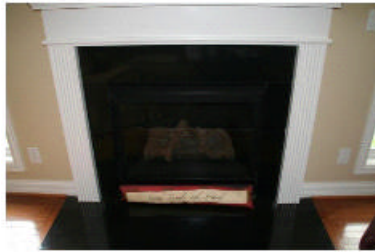
Gas - The fireplace is designed to use gas fuel only. The fireplace has a gas starter. It was not lighted. Only an on/off test was performed to determine fuel accessibility. There is a log set installed. Mortar joints are intact, Damper is operational, Hearth Observations: The hearth extends at least 16 inches in front of the firebox and extends at least 8 inches to either side. There is a mantle installed, and it meets the 12"

minimum clearance above the firebox.

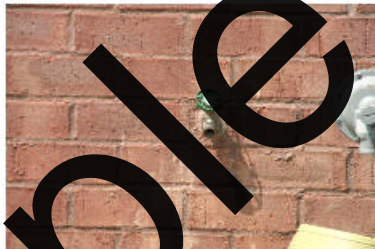
Sample operated, appeared serviceable, DO NOT LEAVE HOSE CONNECTED TO FAUCET DURING COLD WEATHER THIS MAY CAUSE THEM TO FREEZE AND CAUSE DAMAGE.

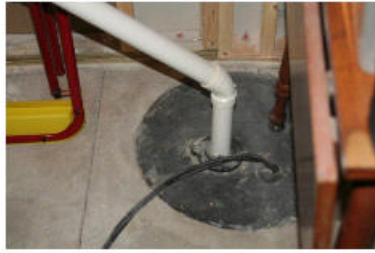
Basement:

p " " The pump appears functional.

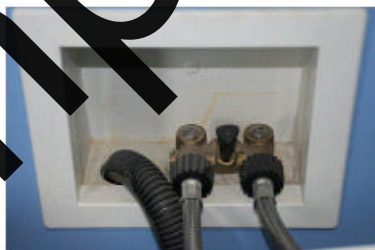
Laundry:

p " " Plumbing appears serviceable, There is a connection box installed in the wall with both hot and cold water and a drain pipe. The drain pipe was not flood tested.

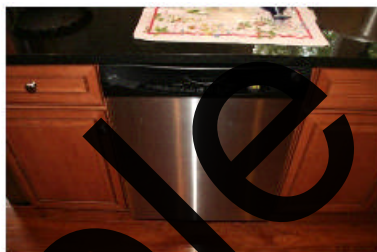
Dishwasher:

properly installed. Air gap device or high-loop is present on drain line- Proper.

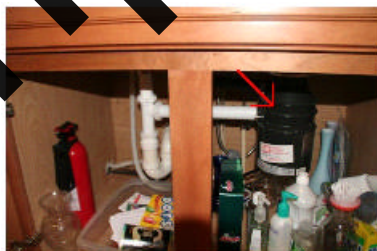
Garbage Disposal:

properly installed. Wiring appears serviceable.

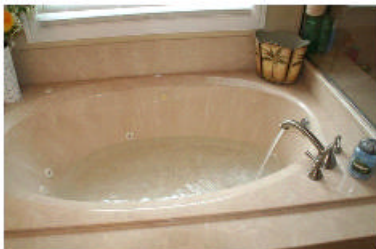
Master Bath:

Hydro-spa is functional, but its supply pipes should be periodically flushed with anti-bacterial cleanser.

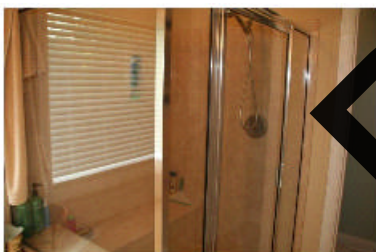
Shower walls appear serviceable. Enclosure appears serviceable.

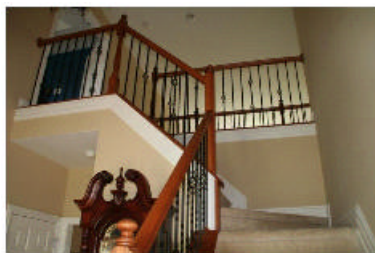
Stairs & Handrails:*Condition:*

Interior stairs serviceable, Stair handrail serviceable.

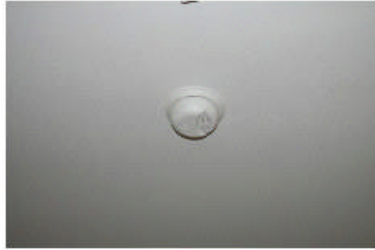
Smoke / Fire Detector:

p " " Smoke alarm(s) responded to test button operation.

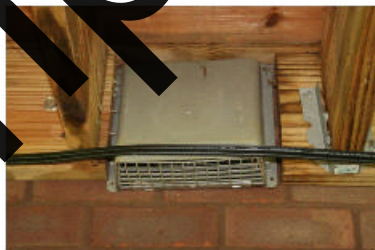
Dryer Vent:

A dryer vent is provided, and in good visual condition. No tears were noted.
